Swimming Pool

DWN: DBT	September 2025	Site Plan	SCALE: NTS
PROJECT:	Swimming Pool		
Client:	District of Port Hardy

WESTCOAST ROOF INSPECTION SERVICES LIMITED	DWG. NO. SP-2	REV.

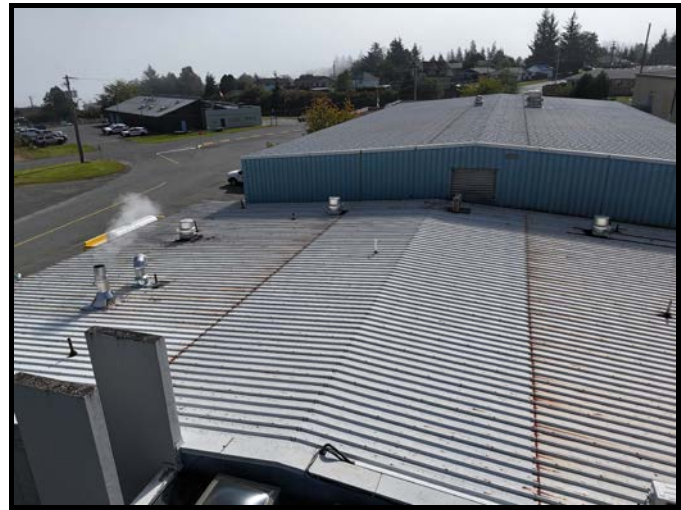
Overview of metal panel roofing on Swimming Pool. The roof over the offices is in the front.

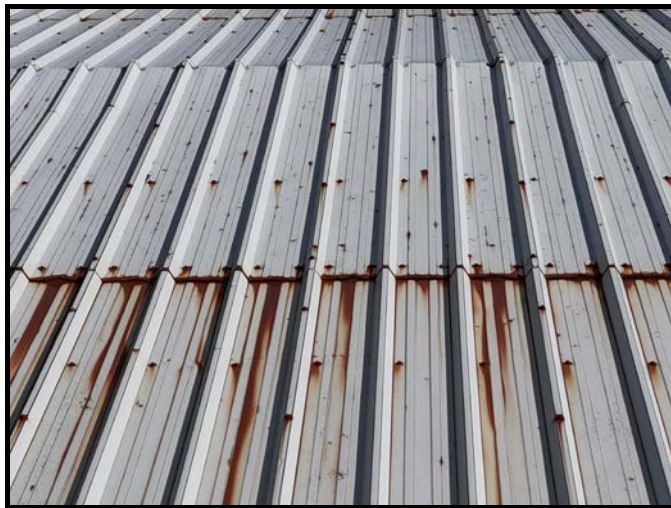
1. The metal panels are scratched and rusted throughout these roofs. The rust is severe at the bottom of panels, some have rusted through the bottom inch. Exposed fasteners are also rusted.
 - *The rusting panels may be from chlorine vapour drive from the pool below and a breach or lack of vapour retarder.*
 - *When replacing the roofing we recommend ensuring new vapour retarder is enveloped to prevent vapour drive through the roofing assembly.*
 - *Repairs should only be performed to stop leaks as necessary until replacement is done.*
2. Curbed vents and new exhaust equipment on the southwest roof area have been repaired using mastic.
 - *Monitor repairs until roof replacement.*

The metal panels are rusted at panel ends and over scratches, as well as the exposed fasteners.

For replacement, we recommend using a standing seam metal panel assembly with hidden fasteners. A vapour retarder should be installed to envelope the roof deck prior to installing insulation and the new metal panel assembly.

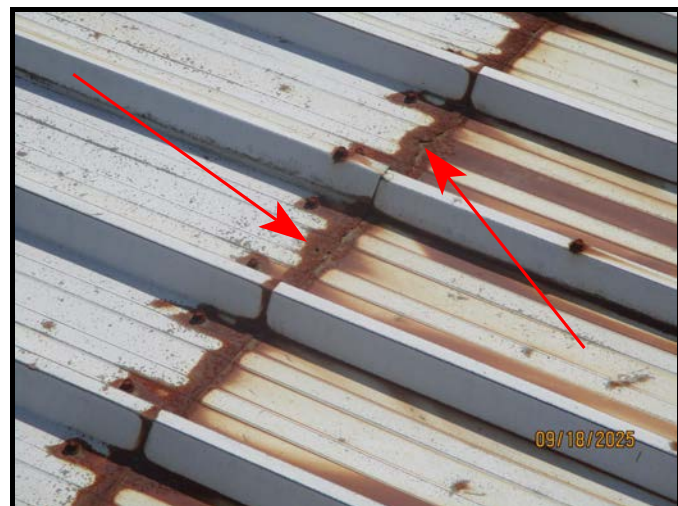
The rust is severe at panel ends. The metal is rusted away at the bottom inch at several locations.

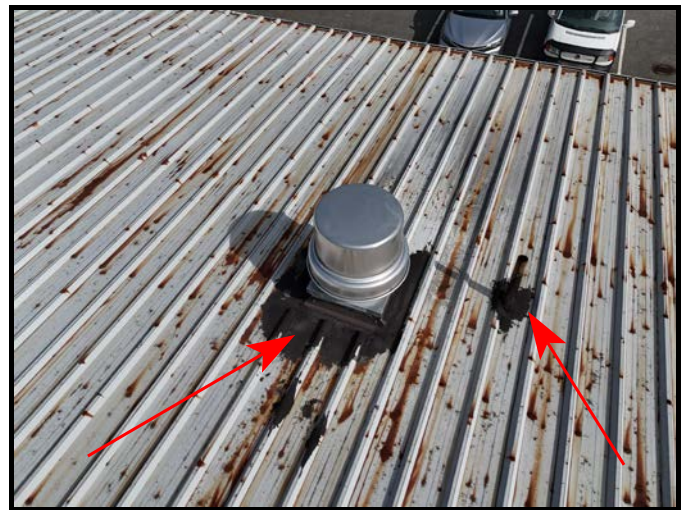
Mastic was used to repair panels at vent curb and plumbing stack on the southwest section.

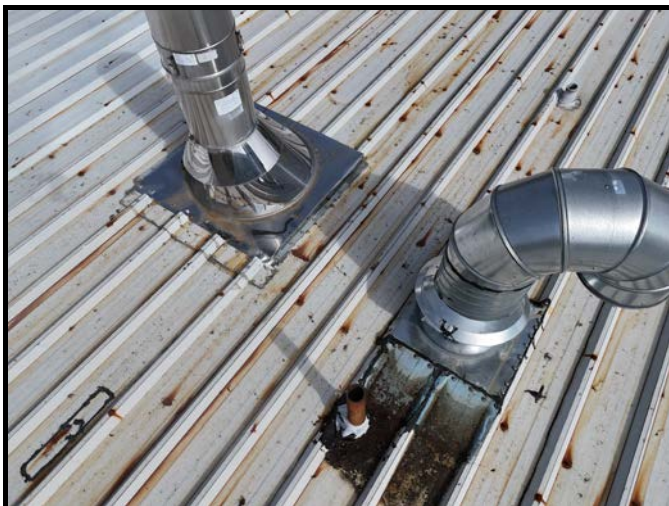
View of new equipment on the southwest roof section.
